Comparative Study of Commercially Available Cleaners for use on Federally-issued Headstones

National Cemetery Administration

Final Report October 24, 2011

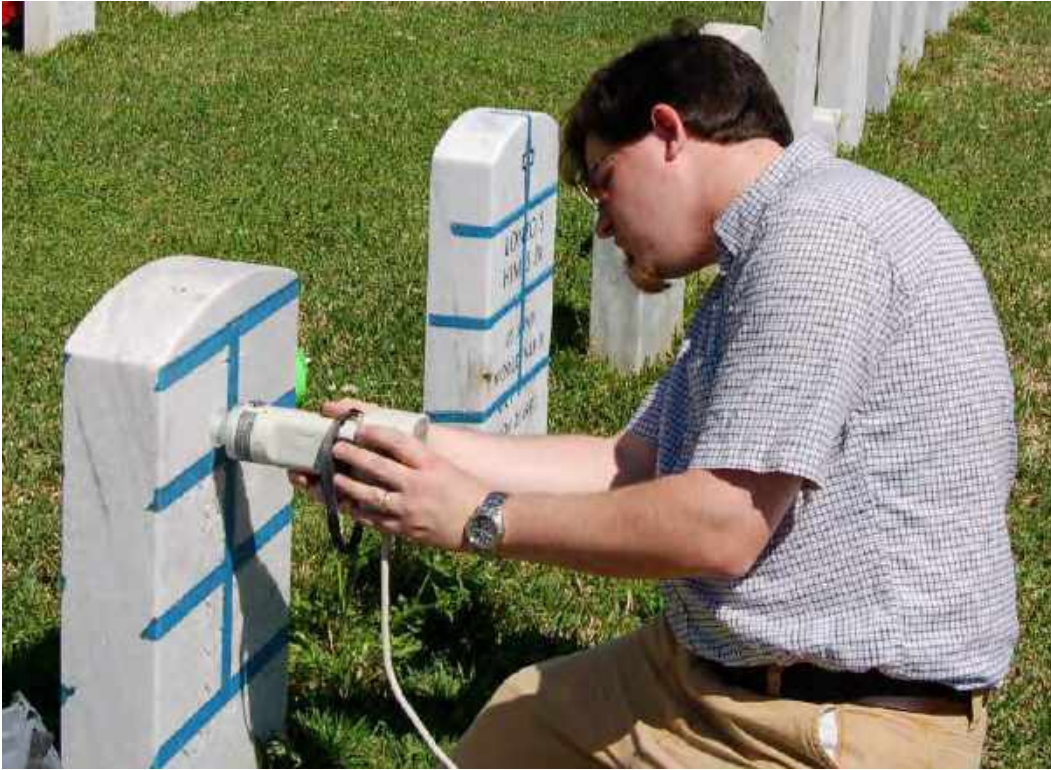
Figure 2. Jason Church positions the head of the Minolta colorimeter for measurements on a headstone in Alexandria National Cemetery.

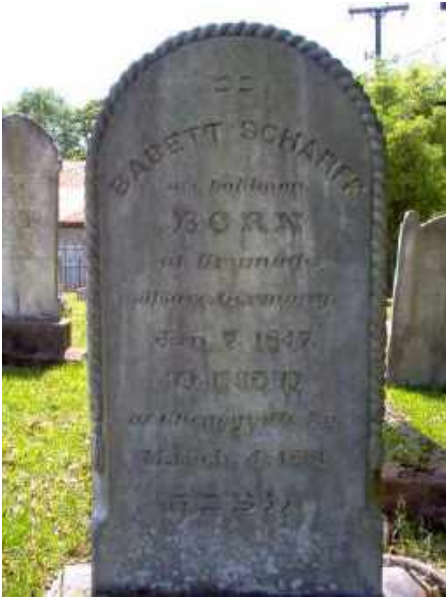
Figure 4. Example of biological growth found on a grave marker in the Jewish Cemetery, Pineville, Louisiana which is located four blocks from Alexandria National Cemetery.

Initially, the presence of higher biological activity at Santa Fe National Cemetery seemed counter-intuitive. Santa Fe is a drier climate and little biological soiling had been observed in the cemetery. Locations such as Jefferson Barracks or Alexandria would be expected to have richer environments for biological growth due to their climates and higher relative humidities. Additionally, a visual survey of private cemeteries in these regions showed typical biological growth, see Figure 4.

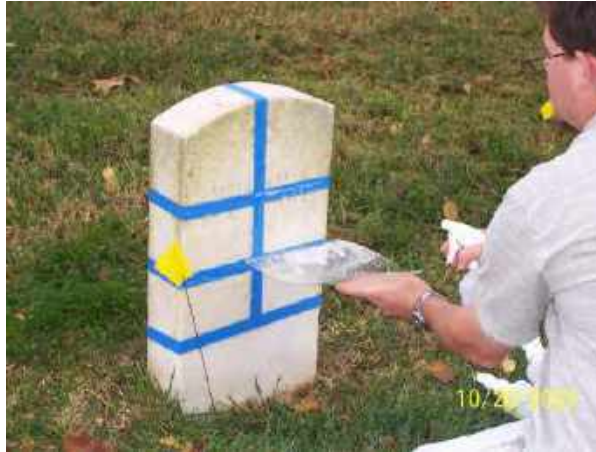
Figure 5. Jason Church applies WEG Marble Cleaner to a taped test patch. He holds a piece of acetate to the stone surface to prevent runoff below the patch. All cleaners were applied following manufacturer's recommendations for dwell time, etc. The stones were subsequently rinsed with water, again using the acetate to prevent runoff.

A grid was taped onto each stone using one inch wide 3M blue tape. Cleaners were applied to the surface of the headstone following manufacturers' recommendations. An 8.5 x 11 inch acetate sheet was used to insure that cleaner did not run to a second test grid. If the stone had raised or engraved lettering, the acetate was taped to the irregular surface. Cleaners were applied in the same test grid on each stone, as shown in Illustration 1 After each test patch was cleaned, the area was thoroughly rinsed with tap water.

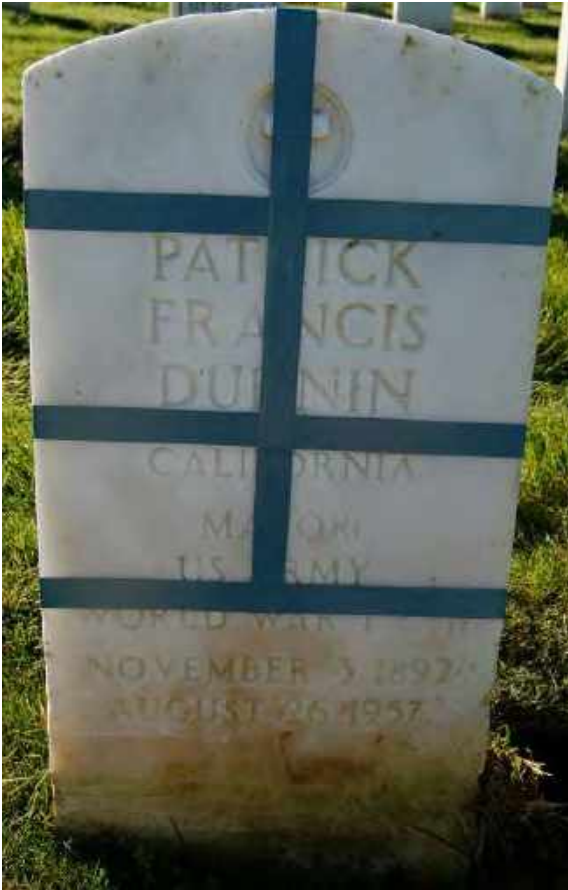
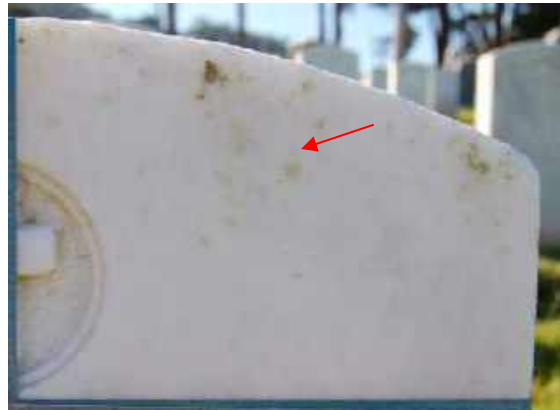
Figure 8. Overview, left, of WS 1032B, San Francisco National Cemetery taken November 2006. Biological re-growth is evidenced on the stone, particularly in patches 2, 4 (above) and 6 (below).

Similar observations can be made at other cemeteries. For example, color change was noted in several headstones in San Francisco, including WS 1032 B shown in Figure 8. Based on color measurements, five of the six test patches have changed color by ΔE greater than 5. Most of this color change comes from the darkening of the headstone (negative ΔL^* values). Visual observation supports these measurements. Biological growth can be seen on patch 2 (D2 cleaner) patch 4 (H2Orange cleaner) and patch 5 (WEG marble cleaner). Also, the brown staining seen on the lower portion of this stone is frequently found in the cemetery. Researchers hypothesize that the staining is due to the use of iron fortified fertilizer used by contractors in San Francisco National Cemetery.

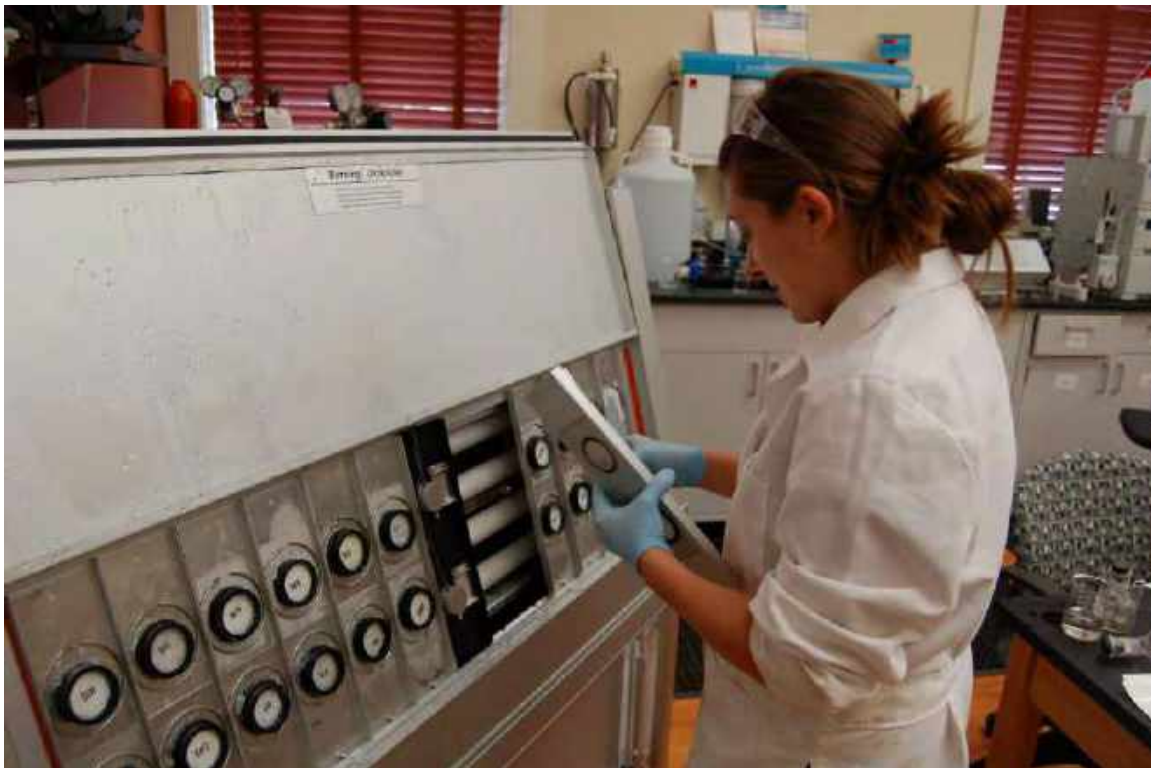
Figure 11. Marble samples being removed from the QUV weatherometer during a dark cycle to be treated with cleaner.

All accelerated weathering studies used a Q- Panel Lab Products model QUV/ Spray Accelerated Weather Tester (weatherometer). This instrument uses panels of UVA-340 lamps to control a programmable cycle of light and dark. The bulbs irradiance level is calibrated to a constant level of 0.77 W/m².

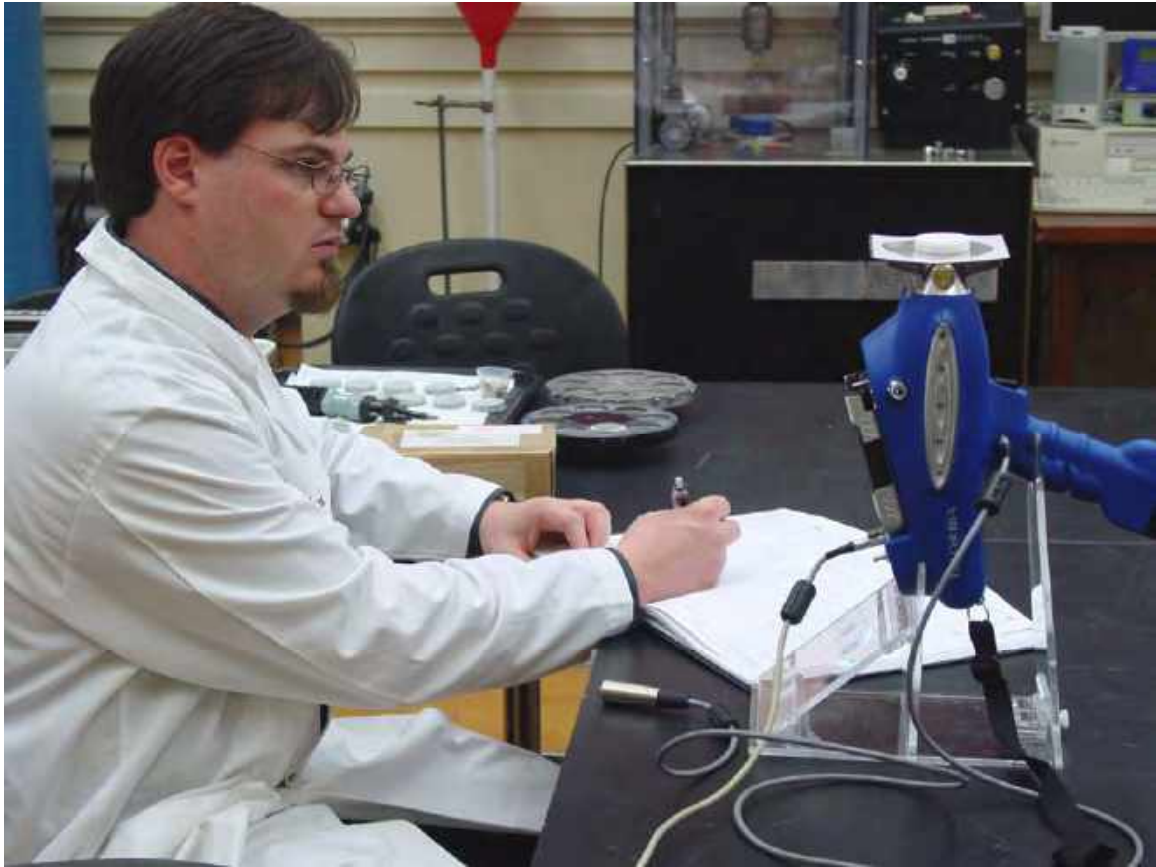
Figure 12. Jason Church uses the XRF spectrometer to analysis a marble sample after artificial weathering.

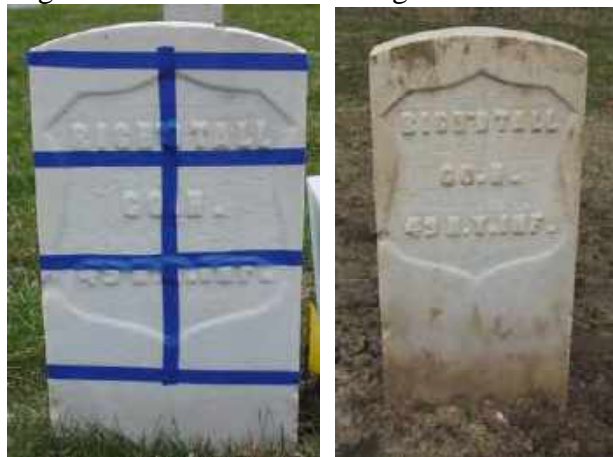
Figure 18. Headstone F712 in April 2006 and again after resetting in November 2006.

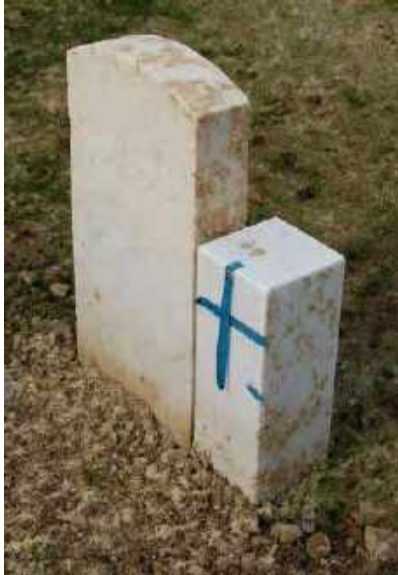
Figure 19. Headstone F812, note that the tan spots are clumps of hydro-seed still attached to the marble.

Through out the sections A, B, D and F, hydro-seeding was used to help with erosion and to replace the ground cover that was lost during renovations. Hydro-seeding is the process of planting mass quantities of grass seed by spraying a slurred mixture over a large area. The mixture for hydroseeding contains five basic components including – a recycled paper pulp, grass seed, tracking dye, fertilizer and a tackifier. The tackifier usually is a linear polyacrylamide polymer that electrochemically binds soil particles. This process could have contaminated the biological data as well as the colorimeter and visual inspection of the all the headstones involved.

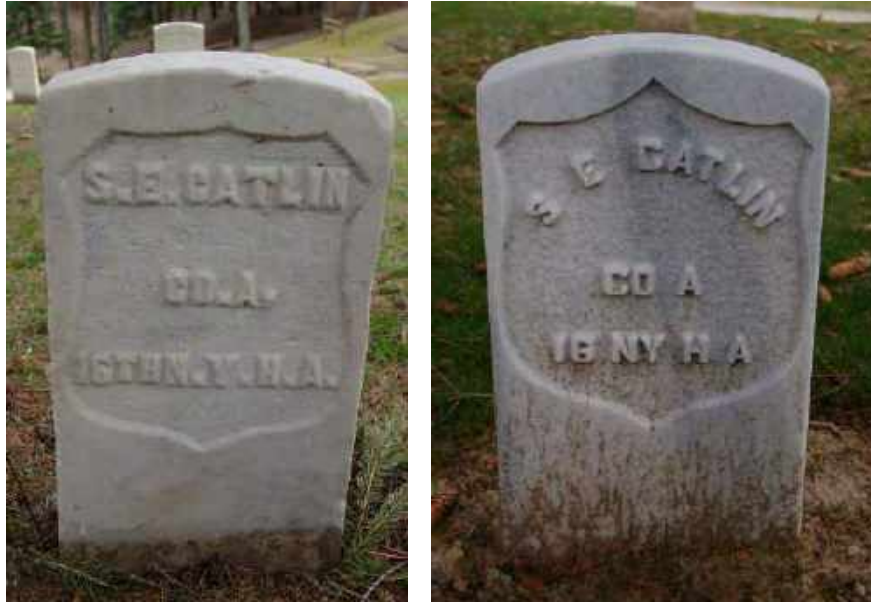
Figure 20. Marker B18 in April 2006 and its replacement in November 2006.

Biological and colorimeter data had been collected on these stones. When asked about the stones the staff stated that they were unaware of which stones had been replaced and that it was believed only the lab samples and their corresponding headstones were still in the study.

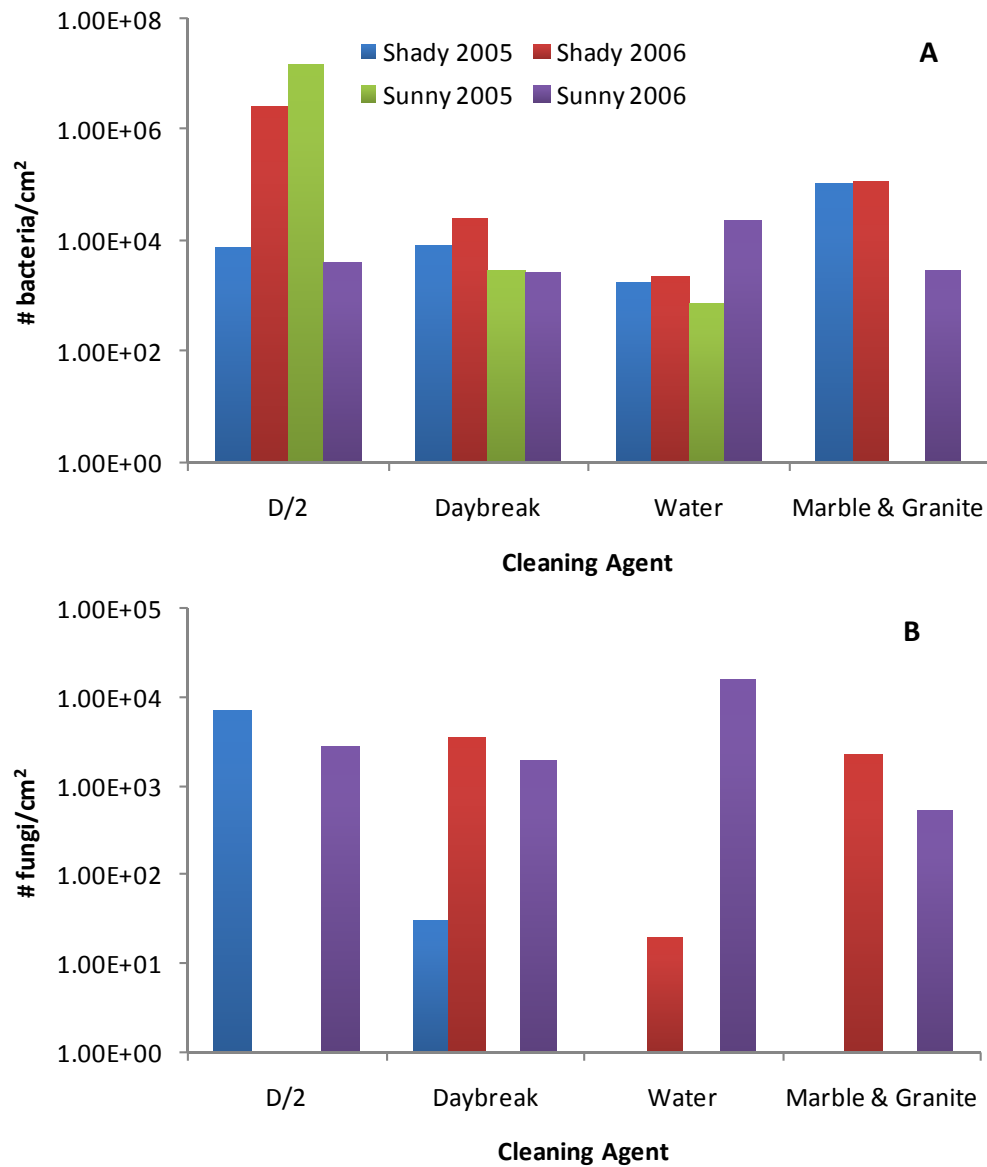
Figure 1. Numbers of bacteria (A) and fungi (B) in Alexandria National Cemetery samples from locations cleaned in 2005 and 2006.

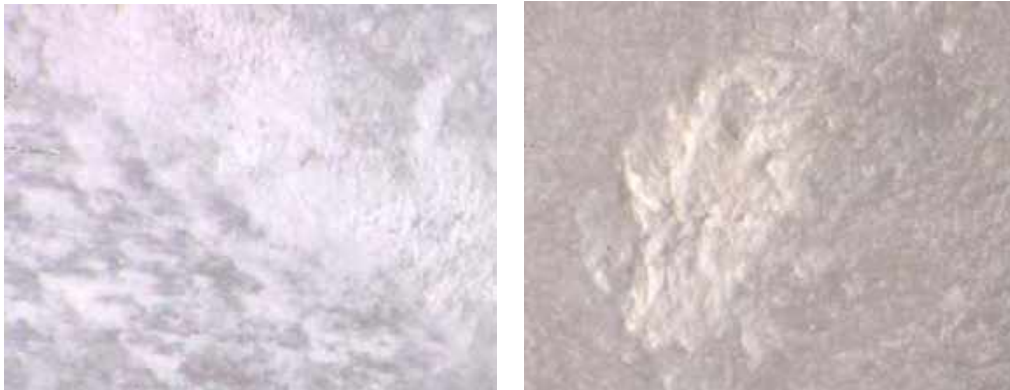
Figure 1. These images were gathered from field samples placed in the cemetery during field trials. The micrograph on the left shows possible salts from D/2 cleaning collecting on the surface of a Colorado Yule sample. The micrograph on the right show possible salts from Daybreak within a pore of the stone. All micrographs were taken at 25X magnification.

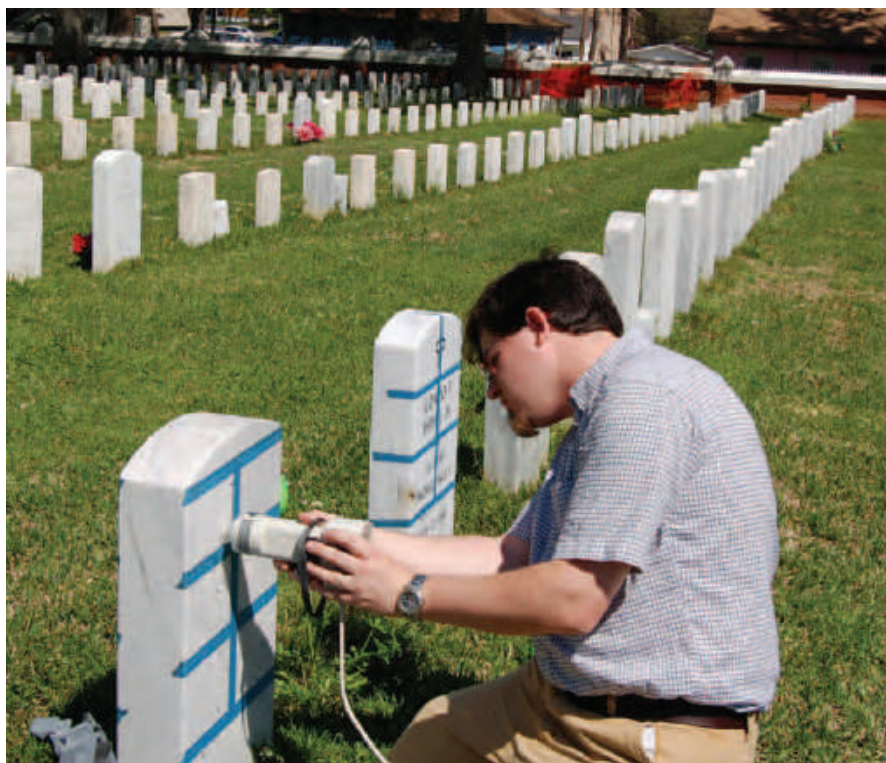
FIGURE 1. Jason Church takes color measurements of a headstone after cleaning.

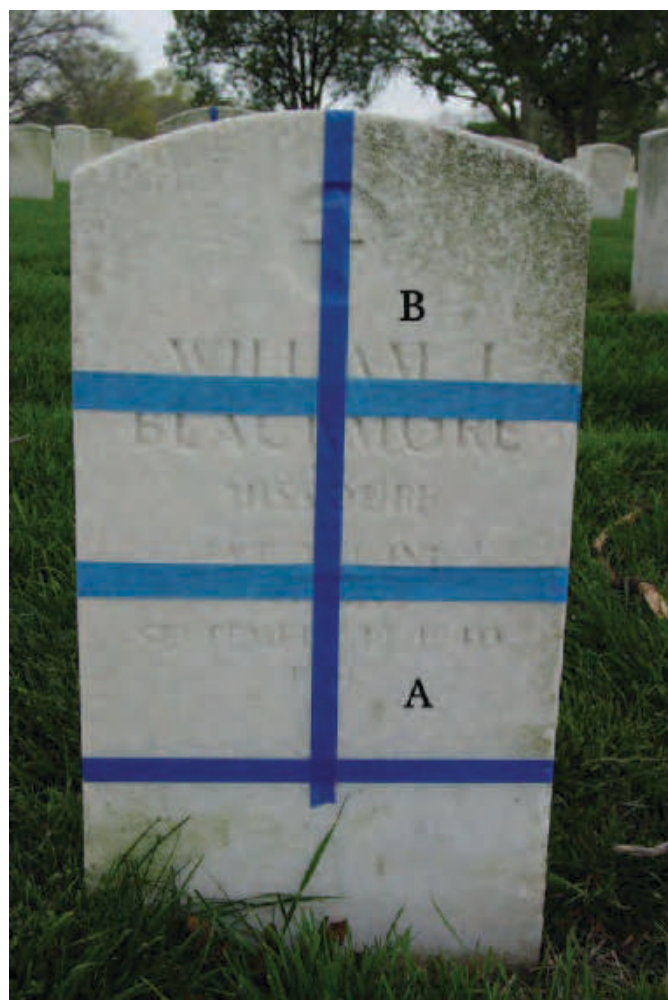
FIGURE 2. Biological growth observed on the test stone at Jefferson Barracks after six months: area A is treated with Kodak Photo-Flo, and area B is treated with $\text{H}_2\text{Orange}_2$ Grout Safe cleaner.
